WORK AT KALENDERHANE CAMII IN ISTANBUL: THIRD AND FOURTH PRELIMINARY REPORTS

CECIL L. STRIKER and Y. DOĞAN KUBAN

THIRD REPORT

FOURTH REPORT

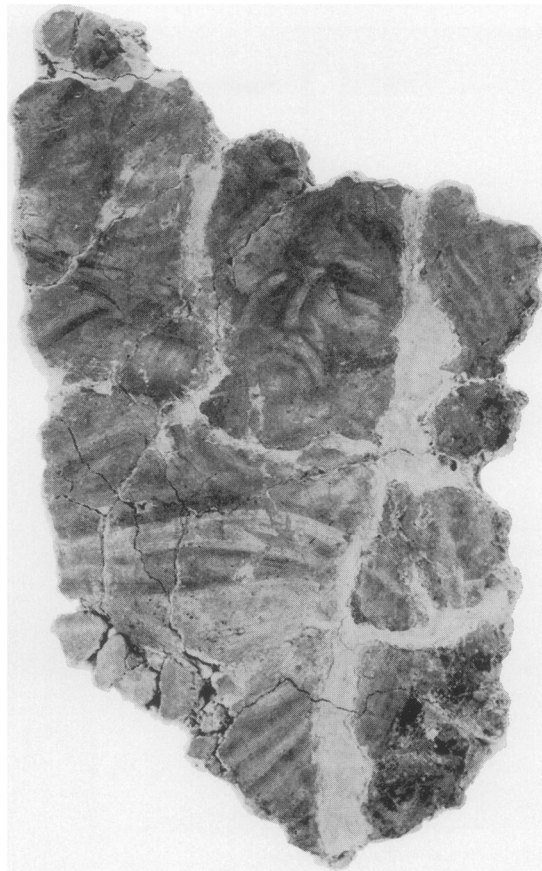
1. Fresco Fragment of Sleeping Apostle from G/6 (max.-length 36 cm.)

In G/6 a large fragment of fallen fresco was discovered with the representation of the head of a sleeping apostle, possibly from a Gethsemane scene (fig. 1). Analysis of the stratigraphic context in which it was found is still inconclusive, but a provisional date in the thirteenth century may be suggested for it on the basis of its style. Originally it must have formed part of the programmatic decoration or the aisle walls above the frescoed dado.

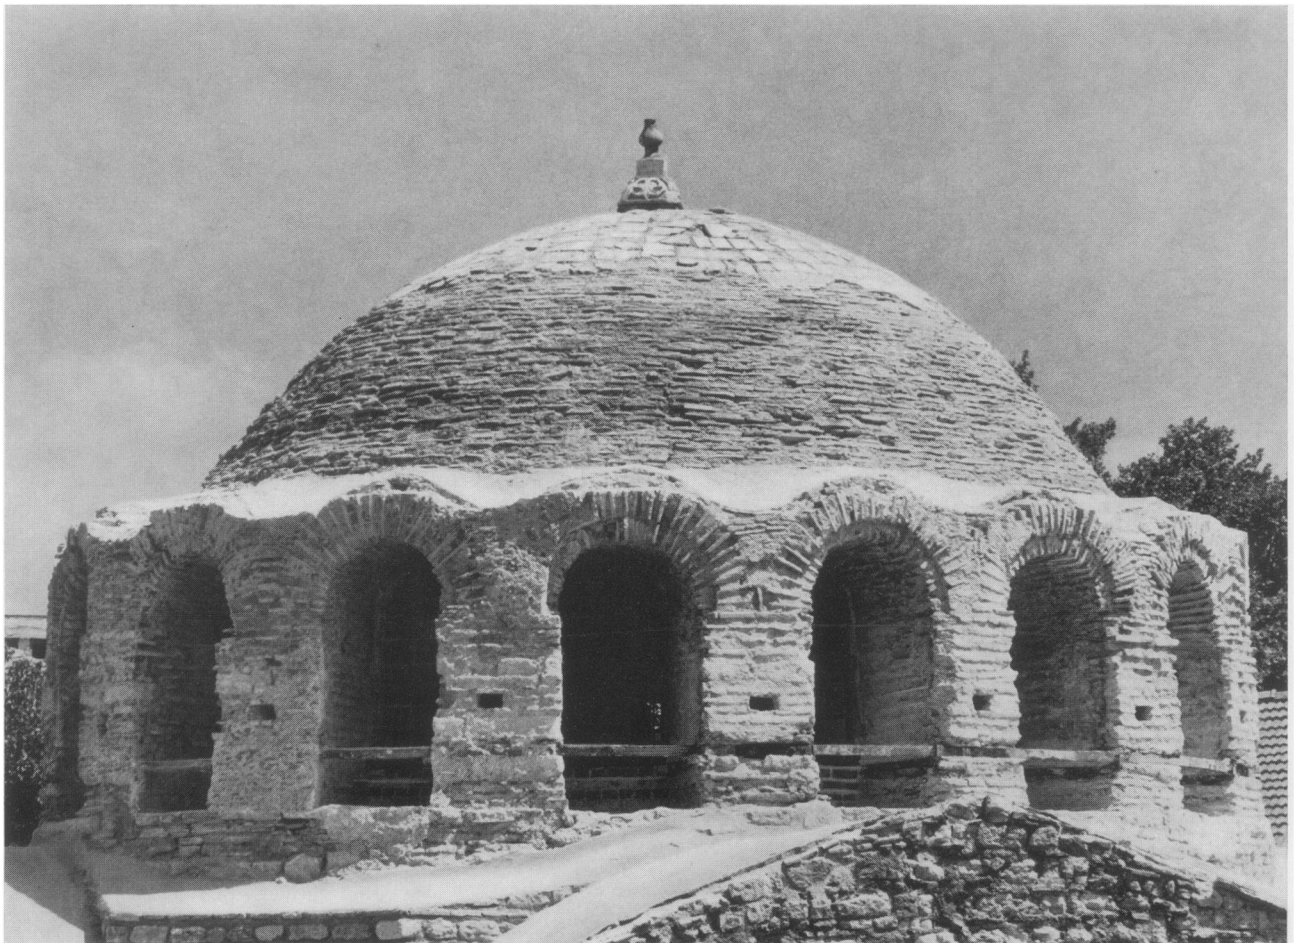
2. West Elevation of Drum and Dome, after Cleaning.
Kalenderhane Camii.

At the commencement of our work the masonry of the exterior of the drum and dome was totally obscured. The outer surface of the dome was covered with a mortar slip overlaid with a thin earth and straw cushion for the lead which formerly covered the dome. The drum was encased in a heavy layer of modern cement, imparting a regular, cylindrical aspect to its exterior (Second Report, fig. 1). The removal of these later accretions revealed the essential features of the underlying structure (fig. 2).

The drum consists of sixteen piers with flat exterior faces, rising directly from the drum base and giving rise in turn to window arches, also with flat exterior faces and double reveals. The system, in other words, is not a regular cylinder, but rather two superimposed sixteen-sided polygons, with clear articulation at the springing of the window arches. The windows extend to the drum base, their lower part having been filled in recent times. Above the window arches and spandrels runs an undulating eaves line, which had also been suppressed by the cement encasement.

Although the drum is damaged, especially on its north side, what remains is of homogeneous construction, with close similarity to the construction of the Main Church phase.

Added to this, the discovery of traces of fresco remains in the window soffits leads us to suggest that the drum is Byzantine, possibly belonging to the Main Church phase.

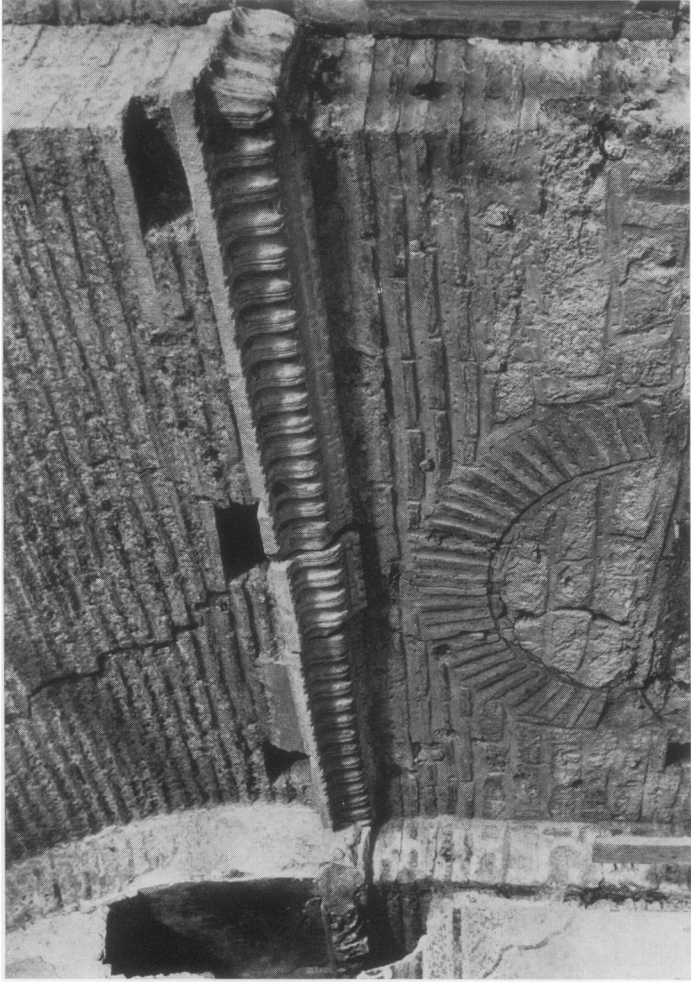
3. East Bema. Upper South Wall and Cornices, looking Southeast

The work of prior seasons had exposed, virtually intact, the two Byzantine cornices running around the interior of the naos and terminating the revetment systems of the ground storey and gallery zones. This consists of simple, undecorated bevelled stringcourses, which had been completely hidden by heavy Turkish plaster cornices.

The cleaning of the east bema revealed that at the points at which the Main Church butts the east bema, the upper cornice changes from this simple stringcourse to a heavy molded cornice, summarily carved with tongue-and-dart decoration, and intact on both sides of the bema (fig. 3). The cornices may be spolia, but the fact that the carving turns the corner at both western ends suggests that they may have been fashioned for their present use and are original. This type of cornice is so commonplace in Early Byzantine architecture that it is of little use as an index of date.

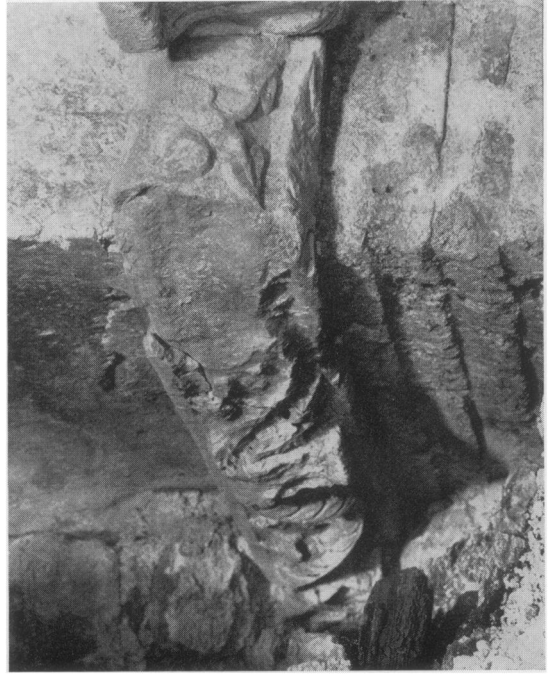
4. East Bema. Detail of Main Apse Cornice, looking Southeast

At the eastern ends of these tongue-and-dart cornices soundings were made in the Turkish closing wall of the bema, exposing the beginning of the turning of the main apse. Here yet another cornice was revealed which originally must have decorated the main apse

(fig. 4). Although badly damaged, it bears the repeated motif of woven baskets giving rise to laurel swags, finely carved in deep relief against a low field of grape leaves. The cornice is reused, since its western ends are decorated with crude crossed palmettes, doubtless carved at the time the cornice was reset in its present position.

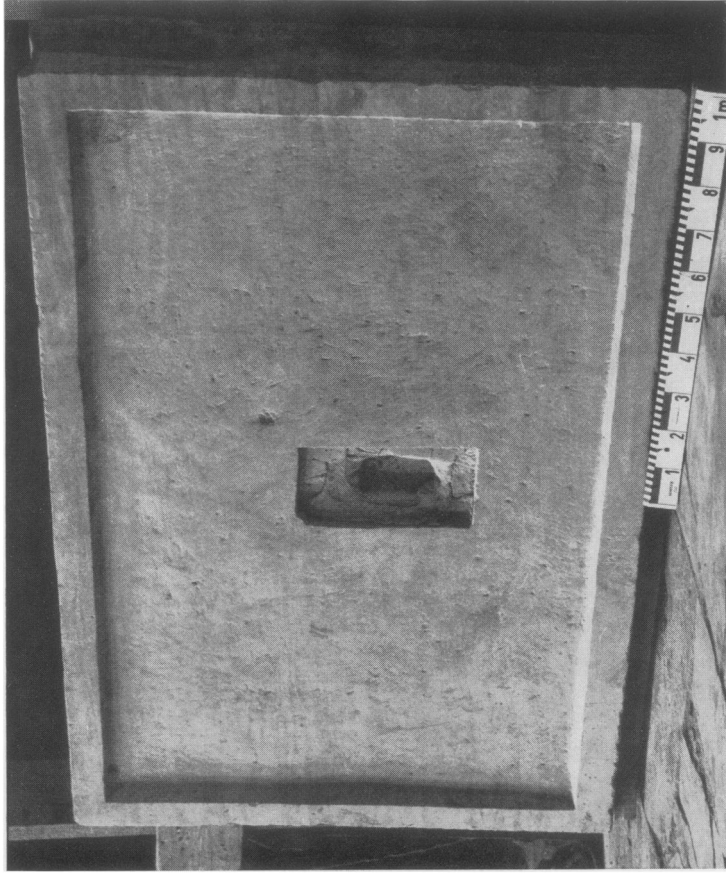
5. Altar Mensa from Bema Paving

One large marble slab in the western part of the bema, when disengaged and turned over, proved to be an altar mensa (fig. 5). The mensa measures 1.06 by 2.03 m. and at its edge 0.17 m. thick. Its edge is worked with a simple molding, subsequently shaved off at the bottom in connection with its reuse as a paving slab. On the top of the mensa a raised flat frame encloses a recessed field. The surface

of the frame and edge molding is smoothly finished, whereas that of the recessed field is only roughly worked. In the center of the field is a roughly cut, rectangular recession, measuring 0.21 by 0.35 m. and 0.05 m. in depth, to all appearances a reliquary grave.³ Traces of plaster setting survive in the recession. The bottom surface of the mensa bears the setting holes for legs, subsequently plugged in connection with its reuse.

Discussion of the original form and reconstruction of the altar must await the further study of comparative examples, but the question may be raised here whether the rough surface of the inner field may not be explained by the fact that the recessed area was originally filled with ornamental inlay. This would also explain the rough, unfinished quality of the reliquary grave, which, if this were the case, would have been left with the expectation that the visible surface of the mensa stone would be enclosed in a finished enframingent.

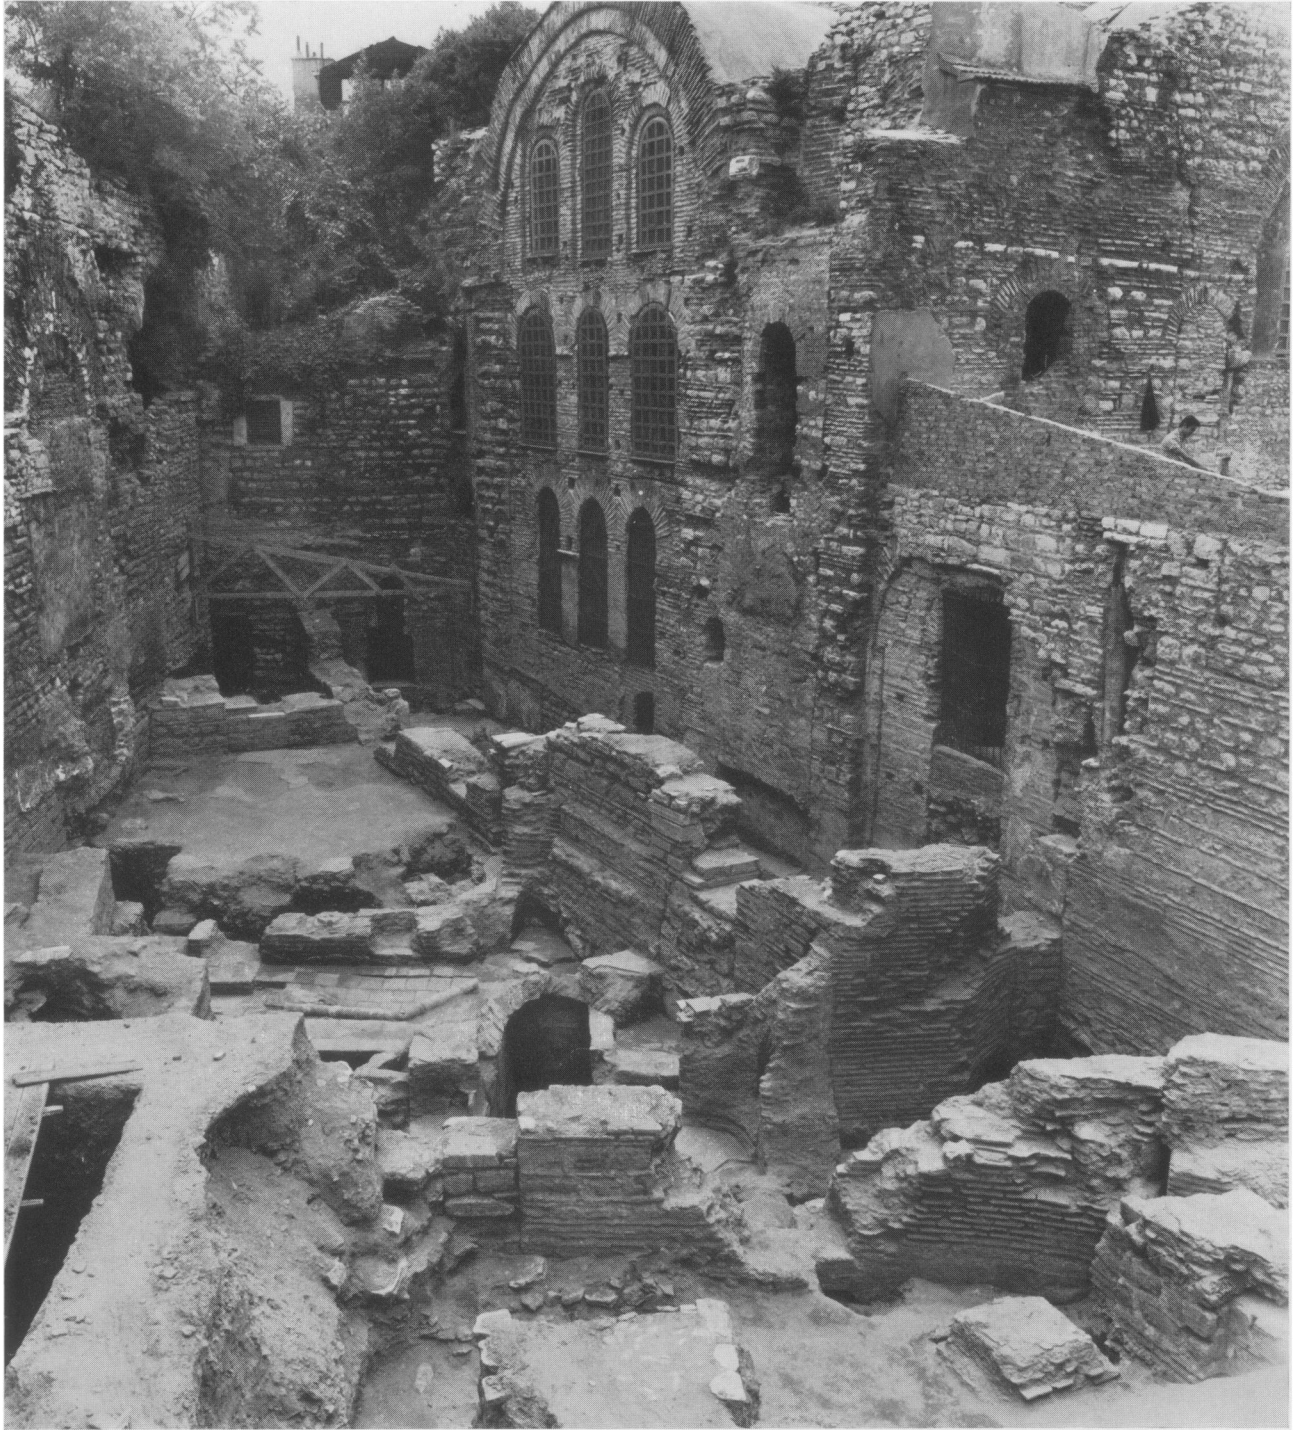
6. Kalenderhane Camii. General View of Excavation to North of Building, looking East

Outside the aisle to the north we found evidence of a paved courtyard, with remains of the marble paving surviving in A/6 (fig. 6). The courtyard is on approximately the same level as the north aisle paving and naos, and is enclosed by the north aisle wall, by the north-south wall cut by grid line A/6-7, by the aqueduct, and by the zigzag wall in A/3-5. It probably extended to the west up to the wall which is roughly parallel to grid line 2-3. The presence of a number of simple graves of twelfth-century date in A-B/4 indicates that the courtyard was used as a cemetery.

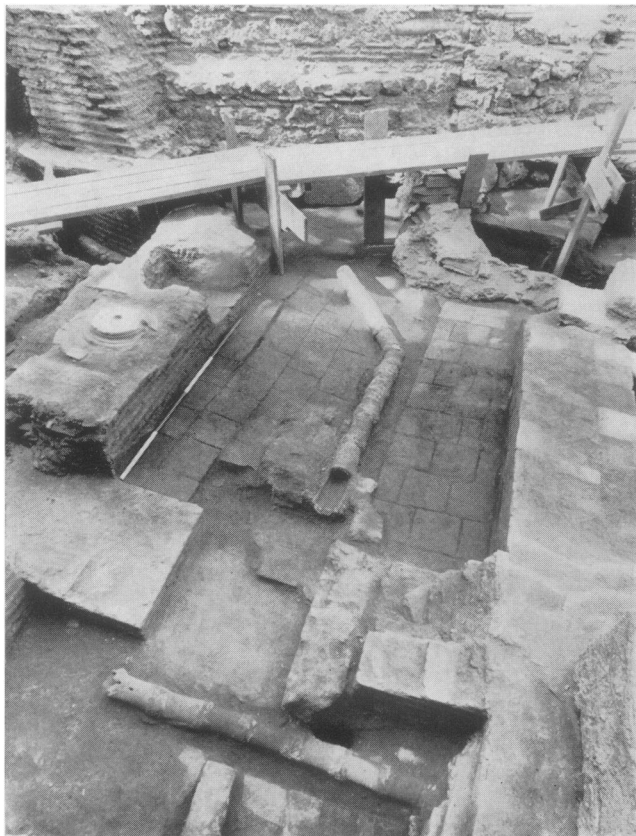
7. Late Roman Bath, Room A, looking South

Portions of this complex, not identified as such, were exposed in prior seasons, partly incorporated in the fabric of the northern part of the two narthexes and partly projecting beyond the existing building to the north.⁶ Further excavation to the north of the existing building has laid free a complex consisting, thus far, of three rooms in varying state of preservation (figs. A and 6). The largest of these rooms, Room A, is situated at right-angle axis to the Valens Aqueduct and consists of a rectangular forechamber (fig. 7) opened by a door at the north, and a larger trefoil chamber to the south. Room B, which flanks it to the south, is a circular chamber, 3.75 m. in diameter, opened by two semicircular niches to the west which in turn flank a door communicating to Room C. Room C, already described in the Second Report, is a circular chamber, 5.00 m. in diameter, with a rectangular niche to the

north opened by a door. Distinctive features of this structure are its fine all-brick masonry and its precision of design.

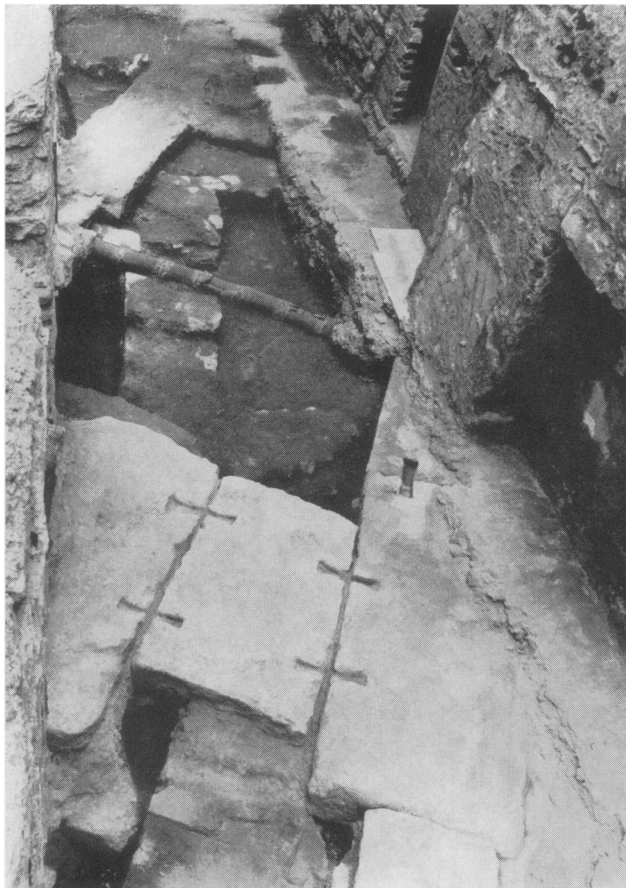
10. Apsed Building, Foundation of Western Extension, looking East

The longitudinal extension of the building to the west, in the form of large foundation blocks, was exposed, in B/5-7 and C/5, directly underlying the paving mortar bed of the excavated north aisle (fig. 10). The blocks, roughly squared, are set in two rows, parallel to the axis of the aqueduct, with three transverse connections. In B-C/5 they were joined with dovetail cramps. In this same zone the blocks rest directly on the dismantled and levelled wall of the eastern lobe of Room A of the bath, thereby fixing, as mentioned above, the construction of the apsed building

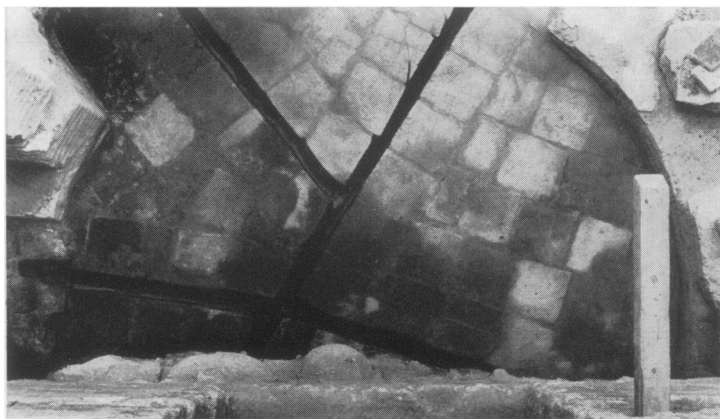
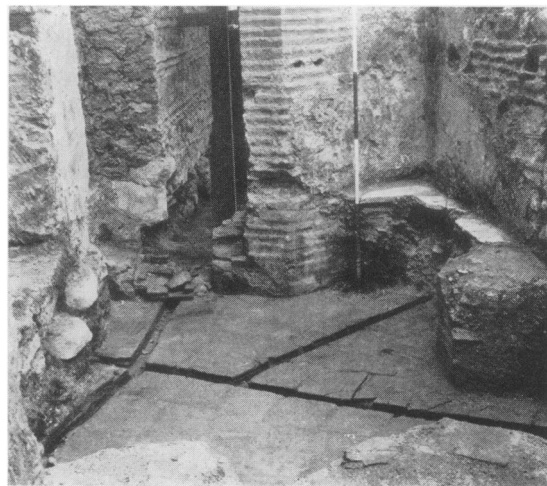
8. Late Roman Bath, Room B, from above (top is North)

A brick tile floor is preserved in much of Room A and is intact in Room B (fig. 8), where it is provided with radial water channels communicating with the flanking rooms and running out of the semicircular niches. A duct also connects the northwest niche of Room B with the area outside the door of Room C at a height of one meter above the tile floor.

Although no remains of hypocaust were found, indirect evidence indicates the preserved floors of Rooms B and C, and probably A, to have been the floor of a hypocaust, the original floor of the bath having been carried approximately one meter above it. This can be deduced from the presence of the channels in the floor of Room B and from the fact that the reveals of the door connecting Rooms B and C extend down only to a level of one meter above the preserved tile floor (fig. 9). Below this the passage narrows and is provided with ducts: a sub-floor system, in other words. The presence of predominantly sixth-century pottery fragments in the fill immediately overlying the tile floor suggests that the *suspensurae*, which may be presumed once to have carried the floor, had already been robbed by this date.

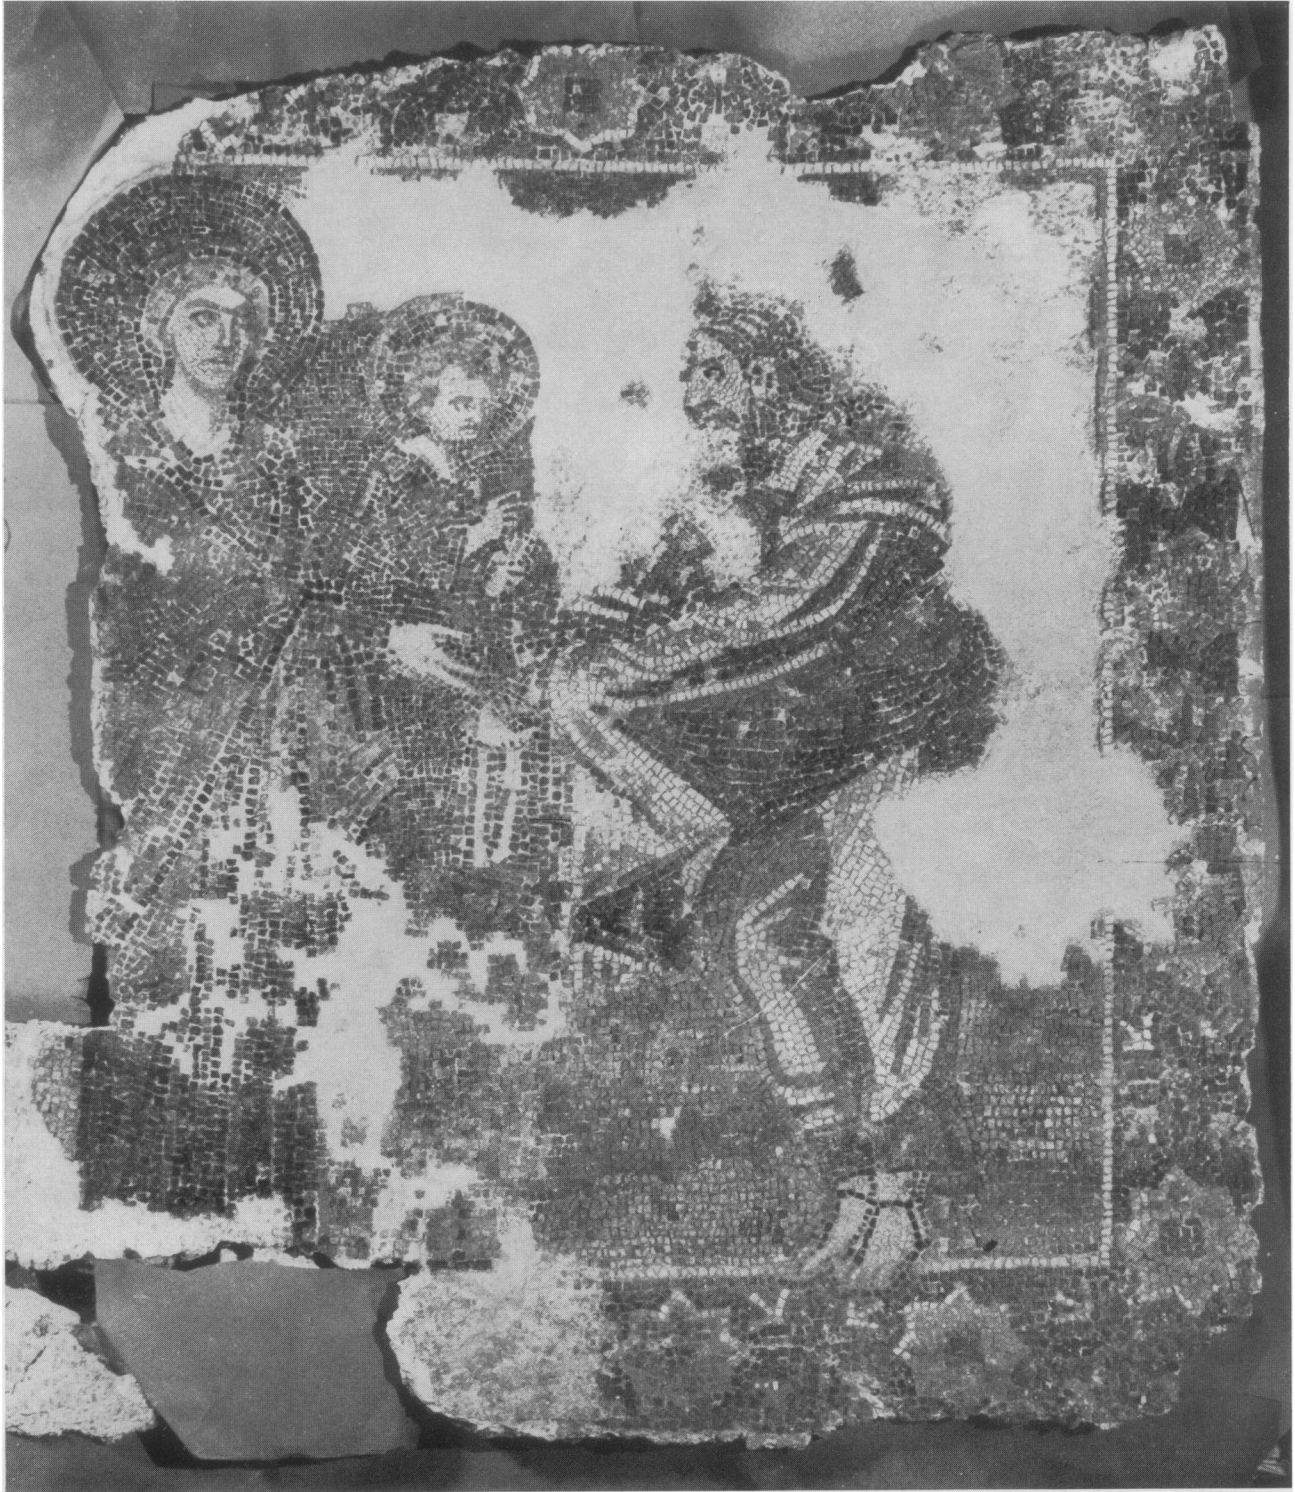
11. Mosaic of the Presentation of the Christ Child in the Temple, after First Stage of Conservation

In the course of conservation and detailed investigation of the south wall of the prothesis, a wall mosaic was discovered representing the Presentation of the Christ Child in the Temple (fig. 11). The complicated context in which the mosaic was found, described briefly below, leaves no doubt that the mosaic and the segment of wall which carries it, represent the remains of an early ecclesiastical structure. Mosaic and carrying wall are, moreover, the earliest structural remains which can be associated with an ecclesiastical building on the site. Since they appear to represent a distinct phase, and are the only remains of that phase identified thus far, they have been given the provisional designation "'Presentation' Church phase."

The pictorial field of the mosaic measures 1.00 m. in height, and with its ornamental frame 1.30 m. Originally it was probably square. Despite the losses suffered prior to its discovery, especially in the background and along the left border, the faces and much of the bodies of the three figures are intact. Throughout the mosaic deterioration has affected, in some cases seriously, the condition of the individual glass and marble tesserae.

The scene is that version of the Presentation, or more exactly *Hypapante*, in which Symeon encounters the Christ Child, presented by the Virgin, outside the temple, the three figures being the only elements of the composition. Despite the losses in the mosaic, a careful inspection seems to rule out the original presence of either the temple portal or of other figures.⁹

Further investigation this season revealed that the plaster setting bed of the mosaic was sufficiently detached from its supporting wall to make possible the careful dismantling of the supporting wall without damage to the mosaic, thereby completely exposing the mosaic from the back. By applying a supporting cradle of wood and plaster to its back the mosaic could then be lifted out of its position intact.

On the evidence of style and technique, we are inclined to date the mosaic provisionally before Iconoclasm, basing this on analogies with the mosaics of John VII in Rome.¹⁰ In the complete absence of relevant pre-Iconoclastic mosaics from Constantinople to which this may be compared,¹¹ the extreme difficulties in dating must be emphasized. On the other hand, there is nothing in the available evidence thus far which would contradict a date sometime between the last part of the sixth and the beginning of the eighth century. Confirmation of a date for the mosaic in this period would make it the only surviving pre-Iconoclastic programmatic church mosaic from Constantinople and the earliest surviving *Hypapante* representation in Byzantine art.¹²

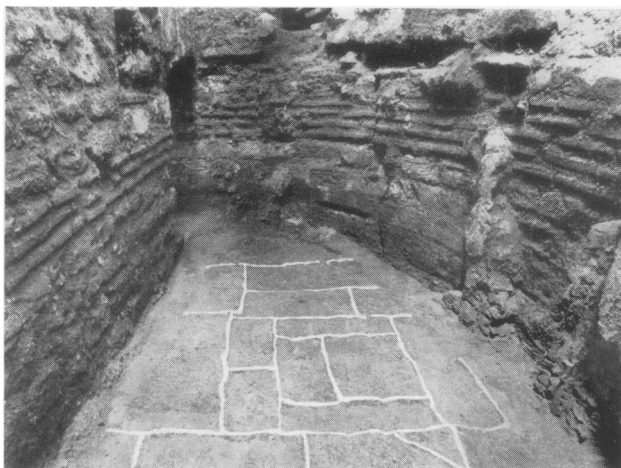
12. Main Apse behind East Closing Wall, looking North (paving joints heightened in white)

Since only the stumps of the main apse are visible on the eastern exterior where the ground level is more than five meters above that of the interior, we wished to determine whether any part of the apse had survived and to establish, if possible, the date of its destruction. A passage was cut in the north end of the flat closing wall where it butts the beginning of the apse, and through this the earth fill immediately behind the closing wall could be excavated. The extent of excavation was limited here by the high exterior level. But the interior face of the semicircular apse, preserved to an average height of one meter,

was laid free (figs. A and 12), together with the mortar bed of the last phase of bema paving. Excavation beneath the mortar bed revealed the semicircular foundation of a synthronon (fig. A) whose context indicates that it belongs, in all probability, to the East Bema phase. While stratigraphic observations in this area were quite difficult, the erection of the Turkish closing wall of the bema could be set approximately at the beginning of the nineteenth century.

Accessibility to this area, which lies beyond the confines of the building, was preserved by building up the apse wall to a height of 3.5 m. and covering the area with a ferroconcrete ceiling. Further excavation to the east of the building is, under present circumstances, impossible.

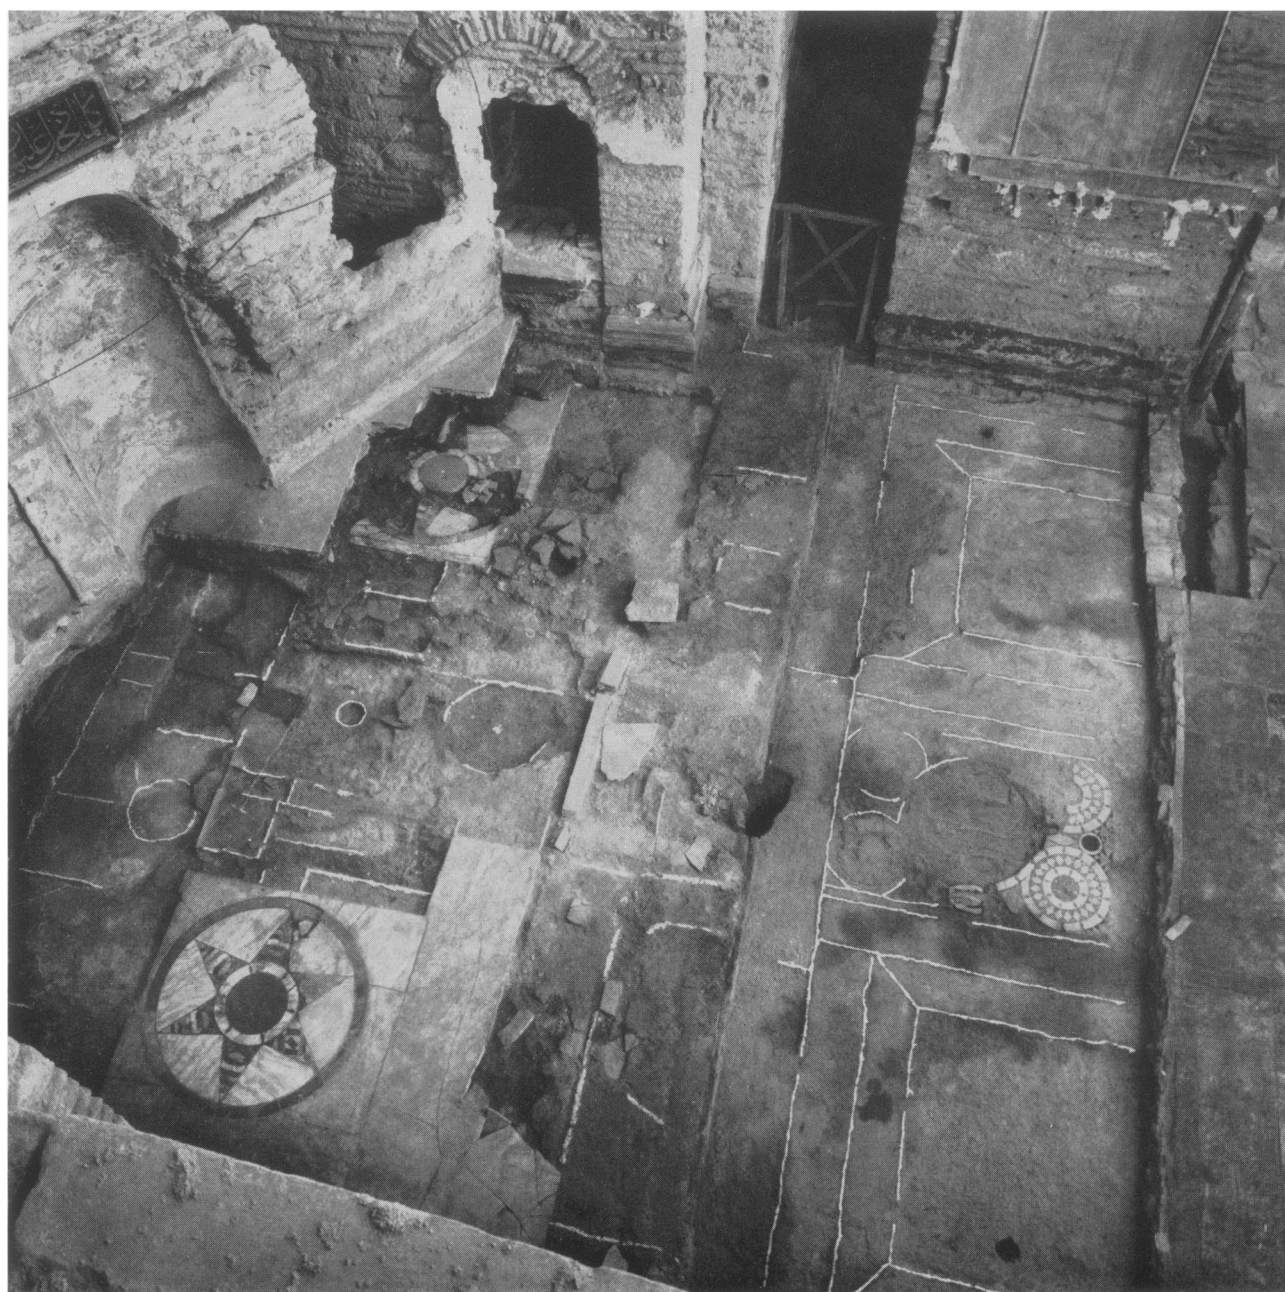
13. Bema, from above, looking South, showing Earlier Paving Phases (paving joints heightened in white)

Excavation in the bema, begun in the third season, was continued. Except where it underlies the mihrab, the Turkish marble paving was entirely raised, disclosing through further excavation the remains of three prior paving phases (fig. 13). These can tentatively be assigned to the East Bema, Main Church and Late Byzantine phases.

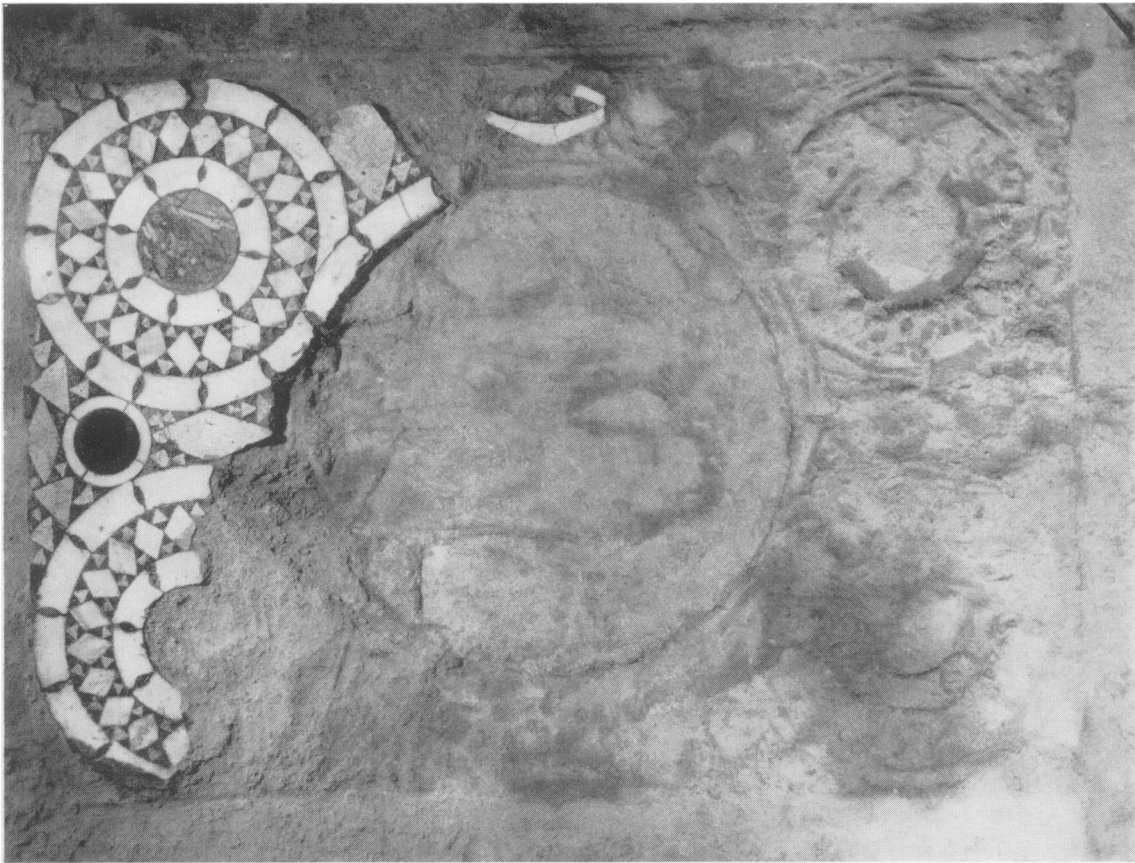
14. Bema Paving, Remains of *opus sectile* Panel with Guilloche

The lowest and earliest of these phases was laid free in a strip spanning the width of the bema between the two main eastern piers of the Main Church. From the paving is preserved the remains of a rectangular *opus sectile* panel (original dimensions 1.26 by 1.86 m.) (figs. A and 14), lying on central axis and decorated with a conventional guilloche motif consisting of a central medallion (original diameter 0.89 m.) and four polychrome rosettes (diameter 0.57 m.) in the corner spandrels.¹³ The guilloche panel was originally flanked to the north and south by simple rectangular panels, the design of which could be recovered from the impression of the marble in the paving mortar. To judge from the enframing system, the panels may have been polychrome. This paving was separated from the eastern part of the bema, by a step spanning the full width of the bema, of which traces of its *verde antico* riser survive. The guilloche system and its step were sup-
